Bio-barrier prevents critters from spreading contamination

Korenza Burris
Fluor Hanford

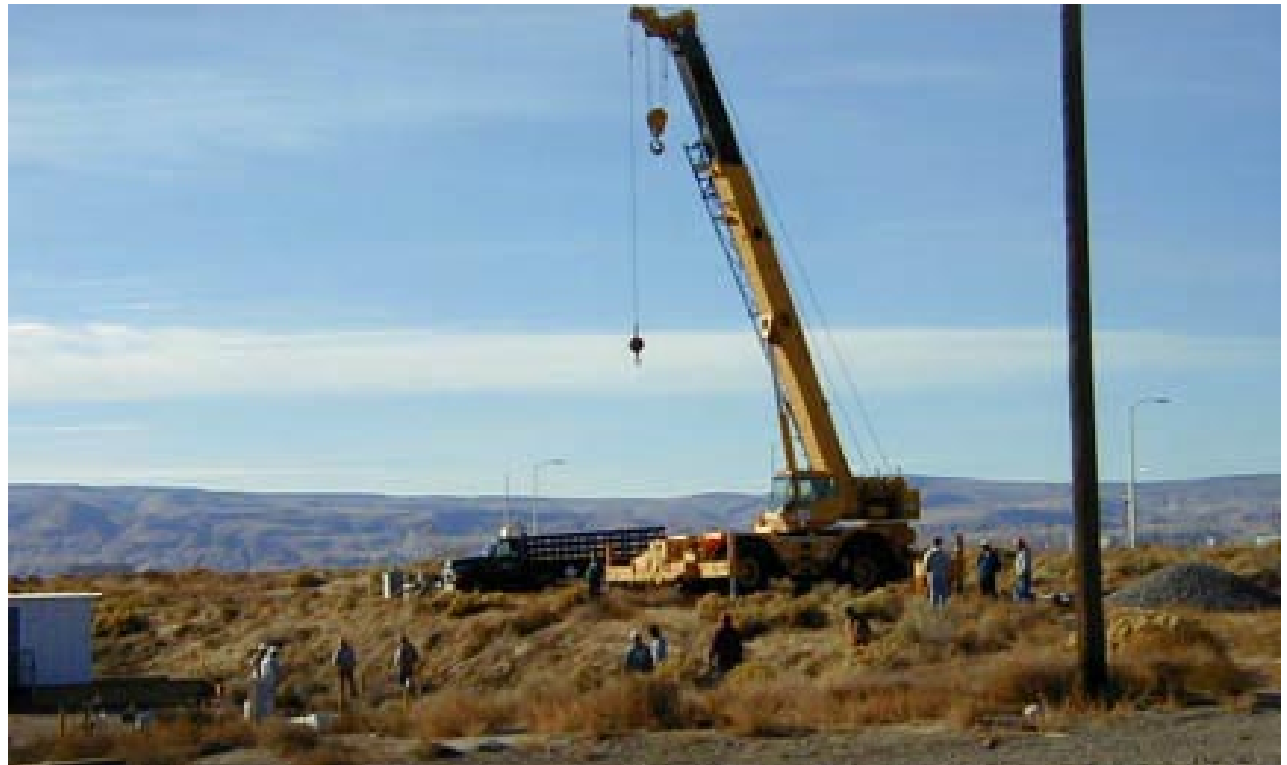
This area near the Plutonium Finishing Plant, previously posted as a surface contamination area, is now categorized as an “underground radioactive material area” as a result of BioGuard II, the product of a local company.

After the bio-barrier fabric is laid on the ground, it is covered with six inches of soil and gravel. This changes the contamination category for the area from a “surface contamination area” to an “underground radioactive material area.”

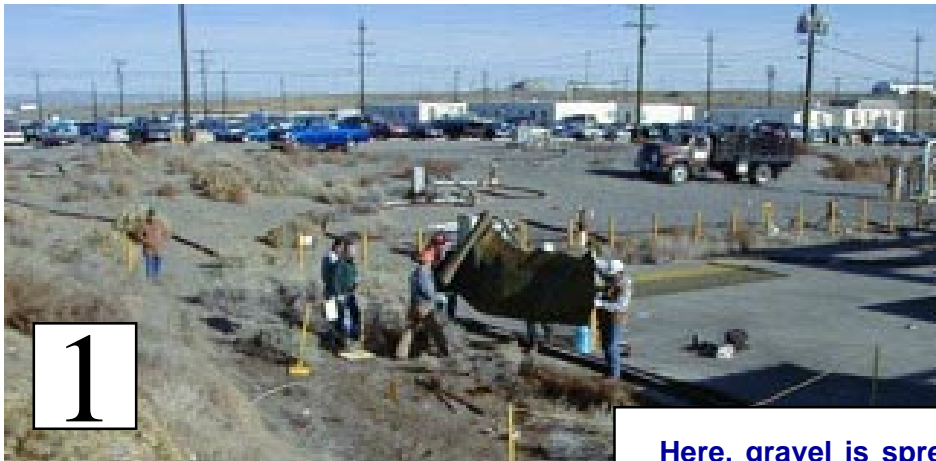
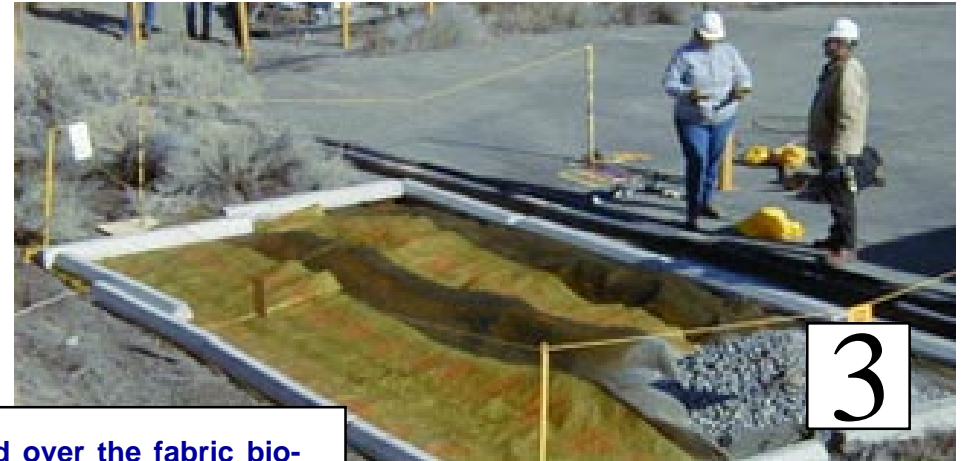
Here, gravel is spread over the fabric bio-barrier material to keep plants and animals from foraging in the contaminated area.
